PHOTOGRAPHIC SURVEY OF THE LDEF MISSION

NASA Special Publication 531

Robert L. O'Neal

Langley Research Center
Hampton, Virginia 23681-0001

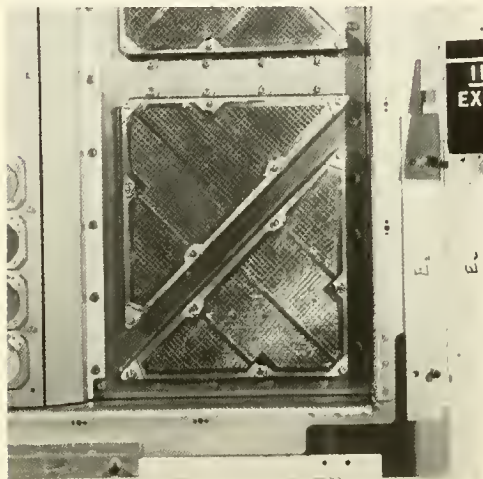
Figure 614 (Postflight). This photograph is of the lower right one-fourth of the tray. The die-cast aluminum frames, fasteners, thermal isolation plate, and polished aluminum stop plate seem to be moderately coated with a brown stain. The stain appears to be more concentrated in vicinities near adhesive bond joints. There are photographic light reflections in the foil sensor surfaces.

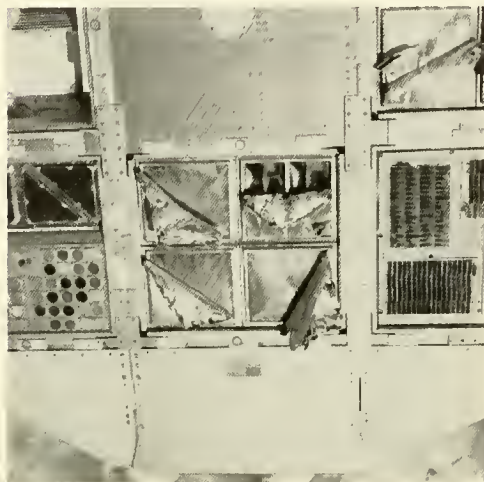
Figure 616
Photo No.: S32-75-067
Dup. Neg. No.: L90-10373
LISAR NO.: EL-1994-00676
Photo Credit: JSC
Photo Date: 1/12/90
Location: In Flight
Subject: In-Flight Survey of Tray H12

Figure 616 (In Flight). The multilayer thermal insulation blankets have extensive damage. The outside blanket surfaces that were originally white are now coated with a glossy dark brown stain. A light coating of the stain is on the tray flange adjacent to the American flag. Note the discolorations on the structure of the LDEF, tray flanges, and tray clamp white dots and the variation of discoloration with proximity to the thermal panel vents.

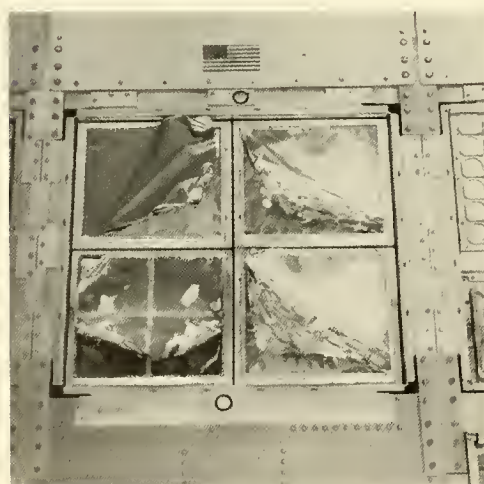
Figure 617
Photo No.: S32(S)-283
Dup. Neg. No.: L92-21190
LISAR NO.: EL-1994-00072
Photo Credit: JSC
Photo Date: 1/22/90
Location: Shuttle Cargo Bay at Dryden
Subject: Postflight Survey of Tray H12

Figure 617 (Postflight). This photograph of experiment M0001 was taken from the cargo bay access hatch of the orbiter during postlanding operations at the Dryden Flight Research Center. The photograph shows the extensive damage to the multilayer thermal blankets. The loose blankets appear to be more tightly rolled than in the in-flight photograph. The outside blanket surfaces that were originally painted white are now coated with a glossy dark brown stain.

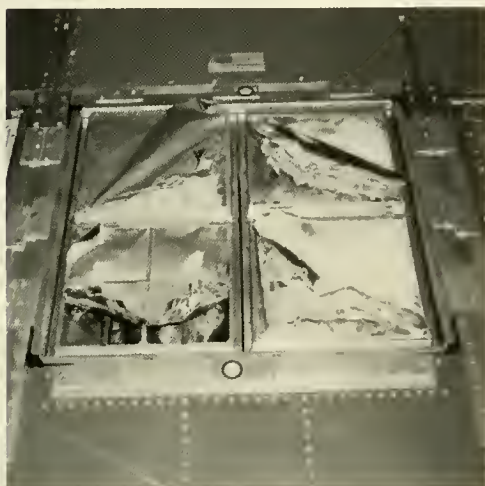
Figure 618
Photo No.: L90-1796
LISAR NO.: EL-1994-00380
Photo Credit: LaRC
Photo Date: 2/6/90
Location: KSC SAEF II
Subject: Postflight Survey of Tray H12

Figure 618 (Postflight). The postflight photograph shows the four experiment modules with multilayer thermal blankets that are severely degraded. Paint on the top layer, previously white, is now a glossy soft brown or tan. The thermal blankets apparently shrunk in flight, thus causing them to detach from the frame along two sides. The tape used to attach the blanket to the structure failed in tension across the width of the tape, thus leaving tape on both the frame and the top layer of the thermal blanket. The thermal blankets on the three large modules have curled to expose the top Lexan layer of the detector stack beneath. The curled thermal blankets that protected the four smaller modules in the lower left now expose the 5-mil aluminized Kapton film pressure covers beneath. The damaged thermal blankets on the right side of the photograph reveal representative cross sections of the multilayer thermal blankets.

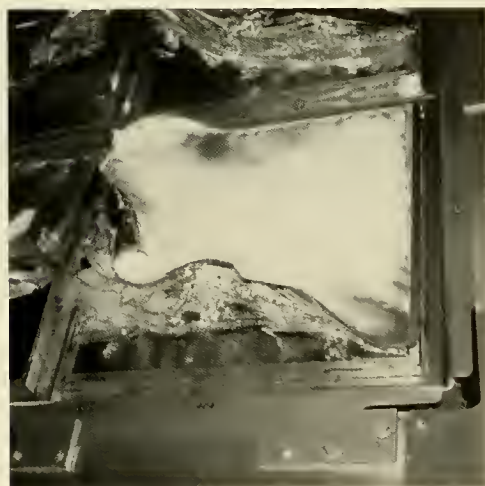
Figure 619
Photo No.: KSC-390C-828.05
Dup. Neg. No.: L91-15548
LISAR NO.: EL-1994-00166
Photo Credit: KSC
Photo Date: 2/6/90
Location: KSC SAEF II
Subject: Postflight Detail of Lower Right of
Tray H12

Figure 619 (Postflight). This photograph is of the lower right one-fourth of the tray. The discolored and damaged thermal blanket is shown. A representative cross section of the blanket is visible.

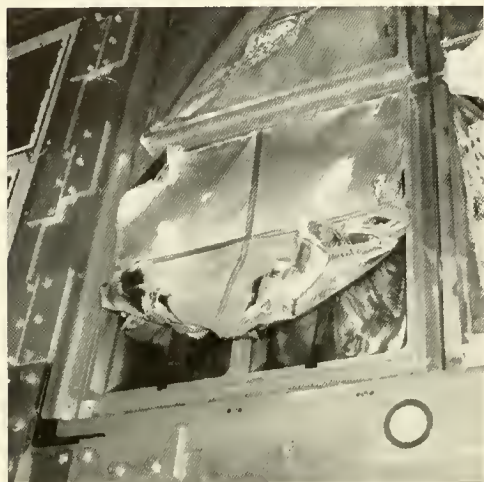
Figure 620 (Postflight). This photograph is of the lower left one-fourth of the tray. The curled thermal blankets that protected the four smaller modules now expose the 5-mil aluminized Kapton film pressure covers beneath.

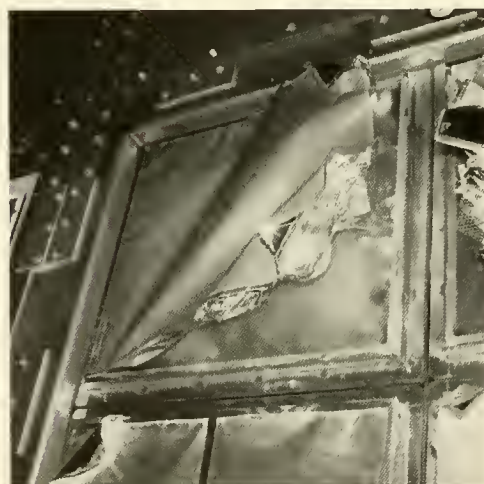
Figure 621 (Postflight). This photograph is of the upper left one-fourth of the tray. The damaged thermal blanket has curled to expose the top Lexan layer of the detector stack beneath.

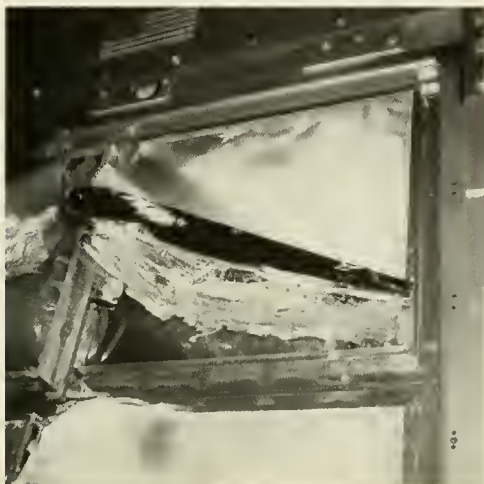
Figure 622
Photo No.: KSC-390C-828.08
Dup. Neg. No.: L91-15551
LISAR NO.: EL-1994-00169
Photo Credit: KSC
Photo Date: 2/6/90
Location: KSC SAEF II
Subject: Postflight Detail of Upper Right of
Tray H12

Figure 622 (Postflight). This photograph is of the upper right one-fourth of the tray. The discolored and damaged thermal blanket is shown. A representative cross section of the blanket is visible.

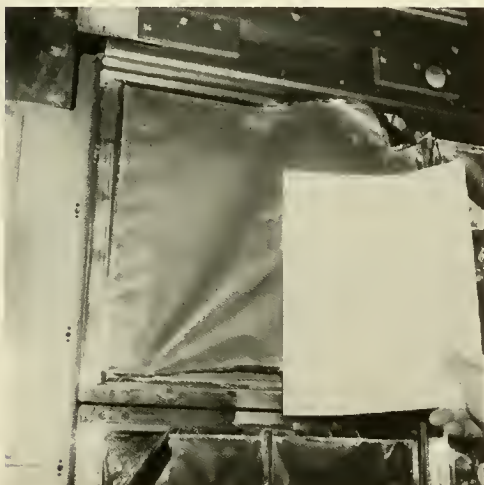
Figure 623
Photo No.: KSC-390C-829.02
Dup. Neg. No.: L91-15557
LISAR NO.: EL-1994-00283
Photo Credit: KSC
Photo Date: 2/6/90
Location: KSC SAEF II
Subject: Postflight Detail of Tray H12

Figure 623 (Postflight). This photograph shows a white card for comparison with the discolored thermal covers.

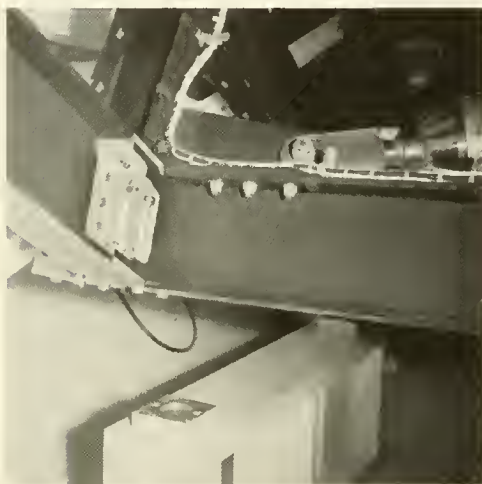
Figure 624 (Postflight). This photograph shows longeron A between rows 12 and 1 with the Earth-facing end to the left. The side of tray A12 was adjacent to this longeron. Little if any contamination on the longeron is visible. Note the discoloration on the intercostal to the left. The edge of the thermal panel location is marked by a line of concentrated brown discoloration. This discoloration was the effect of internal venting. The area covered by the tray flange contrasts with the unshielded area of the intercostal.

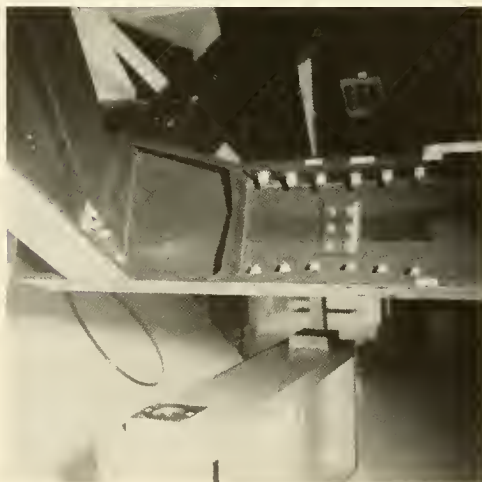
Figure 625 (Postflight). Longeron B between rows 1 and 2 with the Earth-facing end to the left is shown in this photograph. The side of tray A1 was adjacent to this longeron. The light area on the longeron is a reflection off the intercostal end fitting. There is a distinct pattern of discoloration on the side of the longeron. The discoloration on the intercostal is washed out by lighting.

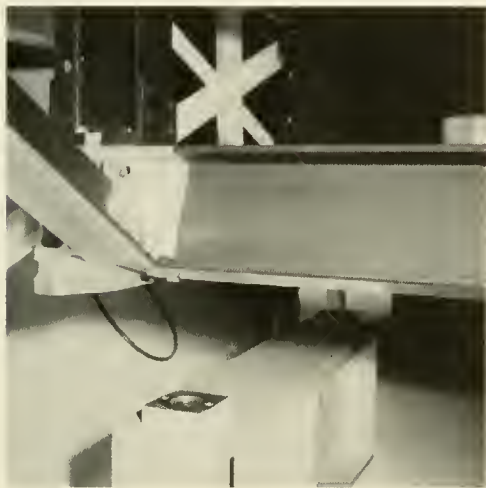
Figure 626 (Postflight). Longerons C between rows 2 and 3 with the Earth-facing end to the left is shown in this photograph. The side of tray A2 was adjacent to this longeron. The light area on the longeron is a reflection off the intercostal end fitting. There is no significant discoloration on the longeron or line of concentrated discoloration at the thermal panel edge location. The area covered by the tray flange contrasts with the unshielded area of the intercostal.

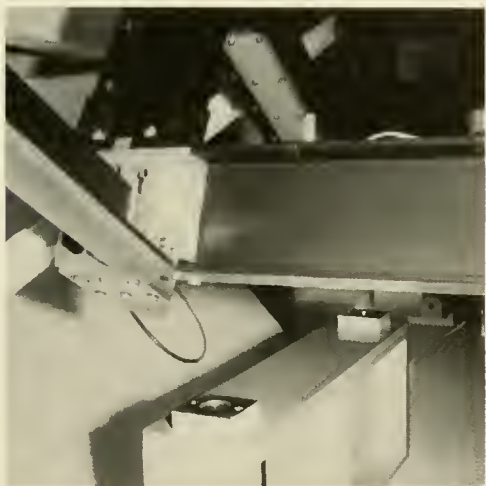
Figure 627 (Postflight). Longerons D between rows 3 and 4 with the Earth-facing end to the left is shown in this photograph. The side of tray A3 was adjacent to this longeron. The light area on the longeron is a reflection off the intercostal end fitting. There is no significant discoloration on the longeron or line of concentrated discoloration at the thermal panel edge location. The area covered by the tray flange contrasts with the unshielded area of the intercostal.

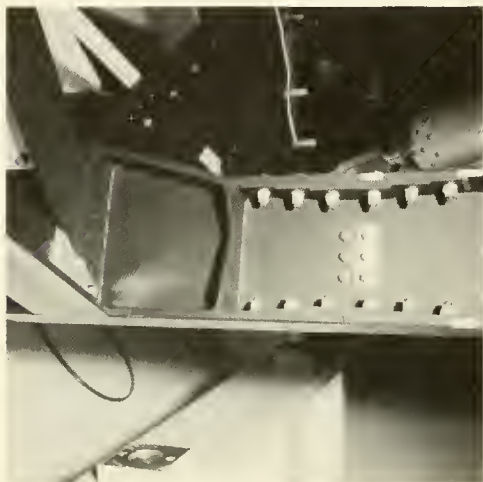
Figure 628 (Postflight). This photograph shows longeron E between rows 4 and 5 with the Earth-facing end to the left. The side of tray A4 was adjacent to this longeron. The considerable area of light on the longeron is a reflection off the intercostal end fitting. There is no significant discoloration on the longeron or line of concentrated discoloration at the thermal panel edge location. The area covered by the tray flange contrasts with the unshielded area of the intercostal.

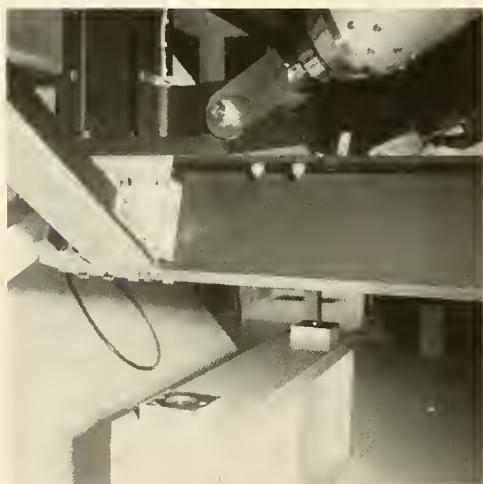
Figure 629 (Postflight). This photograph shows longeron F between rows 5 and 6 with the Earth-facing end to the left. The side of tray A5 was adjacent to this longeron. The light area on the longeron is a reflection off the intercostal end fitting. There is no significant discoloration on the longeron. There is no line of concentrated discoloration at the thermal panel edge location. The area covered by the tray flange contrasts with the unshielded area of the intercostal.

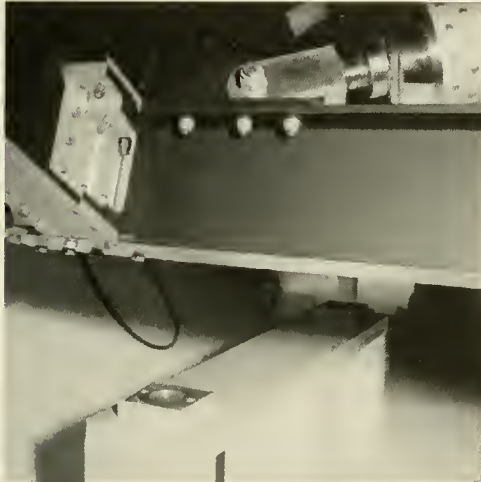
Figure 630 (Postflight). This photograph shows longeron G between rows 6 and 7 with the Earth-facing end to the left. The side of tray A6 was adjacent to this longeron. There is no visible discoloration on the longeron or line of concentrated discoloration at the thermal panel edge location. The area covered by the tray flange contrasts with the unshielded area of the intercostal.

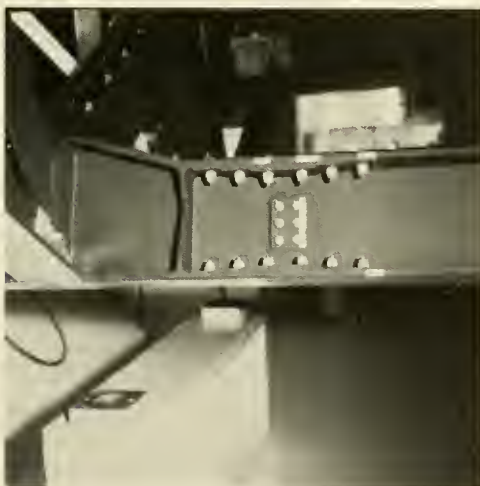
Figure 631 (Postflight). Longeron H between rows 7 and 8 with the Earth-facing end to the left is shown in this photograph. The side of tray A7 was adjacent to this longeron. The pattern of light on the longeron is a reflection off the intercostal end fitting. There is no significant discoloration on the longeron. The edge of the thermal panel location is marked by a line of concentrated brown discoloration. This was the effect of internal venting. The area covered by the tray flange contrasts with the unshielded area of the intercostal.

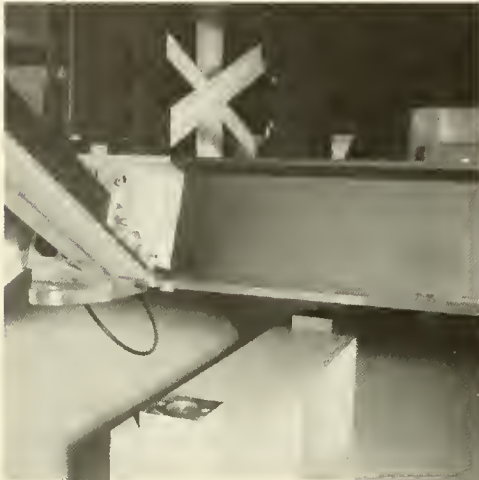
Figure 632 (Postflight). Longerons I between rows 8 and 9 with the Earth-facing end to the left is shown in this photograph. The side of tray A8 was adjacent to this longeron. There is a slight discoloration on the longeron. The edge of the thermal panel location is marked by a line of concentrated brown discoloration. This discoloration was the effect of internal venting. The area covered by the tray flange contrasts with the unshielded area of the intercostal.

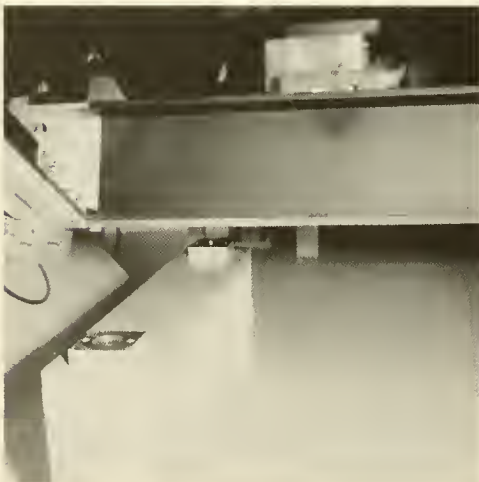
Figure 633 (Postflight). This photograph shows longeron J between rows 9 and 10 with the Earth-facing end to the left. The side of tray A9 was adjacent to this longeron. There is some discoloration on the longeron. The edge of the thermal panel location is marked by a line of concentrated brown discoloration. This discoloration was the effect of internal venting. The area covered by the tray flange contrasts with the unshielded area of the intercostal.

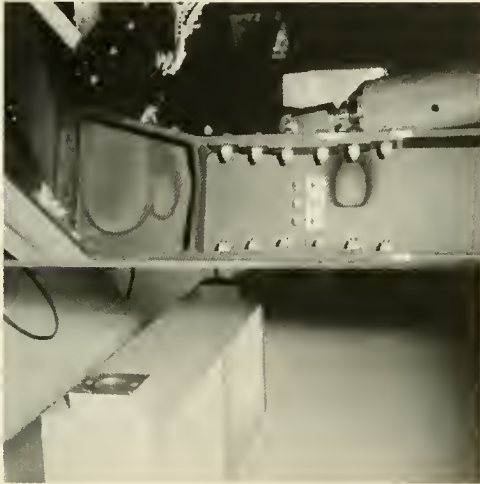
Figure 634 (Postflight). Longerons K between rows 10 and 11 with the Earth-facing end to the left is shown in this photograph. The side of tray A10 was adjacent to this longeron. There are areas of heavy discoloration on the longeron. This pattern of discoloration was the heaviest on longeron K. The edge of the thermal panel location is marked by a line of concentrated brown discoloration on the intercostal. This discoloration was the effect of internal venting. The area covered by the tray flange contrasts with the unshielded area of the intercostal.

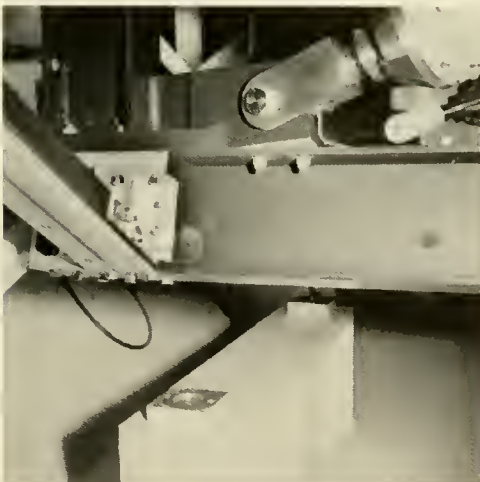
Figure 635 (Postflight). This photograph shows longeron L between rows 11 and 12 with the Earth-facing end to the left. The side of tray A11 was adjacent to this longeron. There are small areas of heavy discoloration on the longeron. The edge of the thermal panel location is marked by a line of concentrated brown discoloration on the intercostal. This discoloration was the effect of internal venting. The area covered by the tray flange contrasts with the unshielded area of the intercostal.

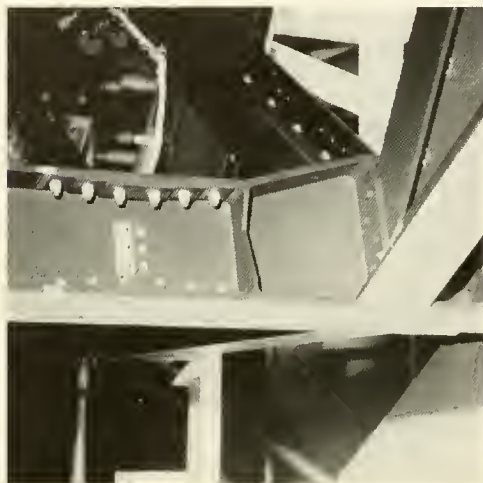
Figure 636 (Postflight). This photograph shows longeron B between rows 1 and 2 with the Earth-facing end to the right. The side of tray A2 was adjacent to this longeron. The pattern of light on the longeron is a reflection off the intercostal end fitting. There is no visible discoloration on the longeron or line of concentrated discoloration at the thermal panel edge location. The area covered by the tray flange contrasts with the unshielded area of the intercostal.

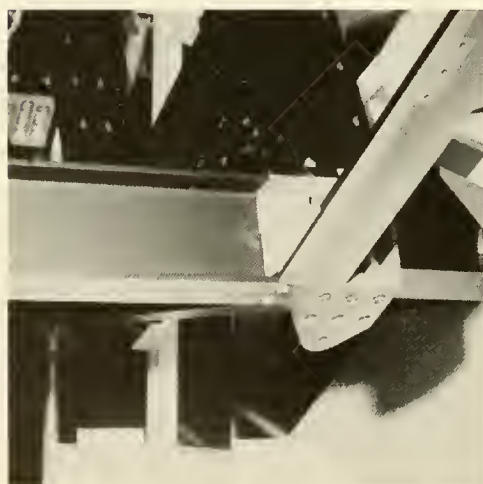
Figure 637 (Postflight). Longeron C between rows 2 and 3 with the Earth-facing end to the right is shown in this photograph. The side of tray A3 was adjacent to this longeron. The pattern of light on the longeron is a reflection off the intercostal end fitting. There is no visible discoloration on the longeron or line of concentrated discoloration at the thermal panel edge location. The area covered by the tray flange contrasts with the unshielded area of the intercostal and longeron.

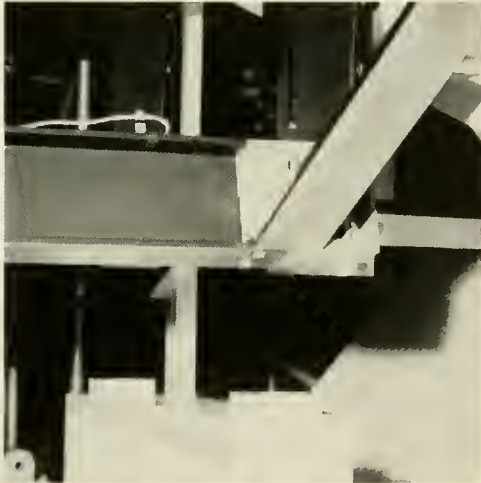
Figure 638 (Postflight). Longerons D between rows 3 and 4 with the Earth-facing end to the right is shown in this photograph. The side of tray A4 was adjacent to this longeron. There is no visible discoloration on the longeron. There is no line of concentrated discoloration at the thermal panel edge location. The area covered by the tray flange contrasts with the unshielded area of the intercostal.

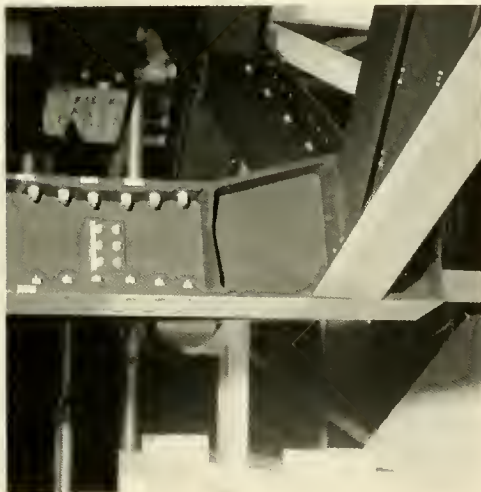
Figure 639 (Postflight). This photograph shows longeron E between rows 4 and 5 with the Earth-facing end to the right. The side of tray A5 was adjacent to this longeron. The pattern of light on the longeron is a reflection off the intercostal end fitting. There is a discoloration on the longeron. There is no line of concentrated discoloration at the thermal panel edge location. The area covered by the tray flange contrasts with the unshielded area of the intercostal.

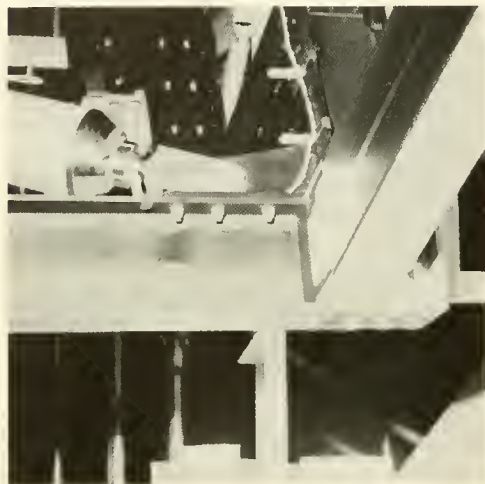
Figure 640 (Postflight). This photograph shows longeron F between rows 5 and 6 with the Earth-facing end to the right. The side of tray A6 was adjacent to this longeron. There is a heavy and distinct pattern of discoloration on the longeron. Note the distinct pattern of the bolts. There is no line of concentrated discoloration at the thermal panel edge location. The area covered by the tray flange contrasts with the unshielded area of the intercostal.

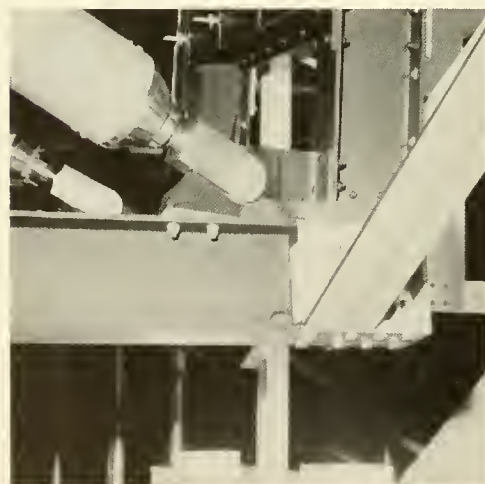
Figure 641 (Postflight). This photograph shows longeron G between rows 6 and 7 with the Earth-facing end to the right. The side of tray A7 was adjacent to this longeron. There is a small pattern of discoloration on the longeron and on the diagonal structural member fitting. There is a distinct line of concentrated discoloration at the thermal panel edge location. This discoloration was the effect of internal venting. The area covered by the tray flange contrasts with the unshielded area of the intercostal.

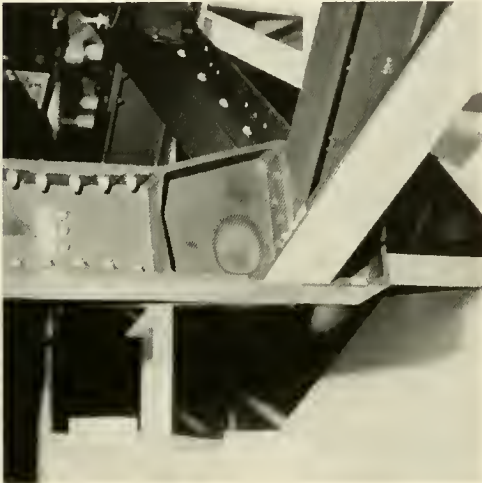
Figure 642 (Postflight). Longerons H between rows 7 and 8 with the Earth-facing end to the right is shown in this photograph. The side of tray A8 was adjacent to this longeron. There is a pattern of discoloration on the longeron. There is a distinct line of concentrated discoloration at the thermal panel edge location. The area covered by the tray flange contrasts with the unshielded area of the intercostal.

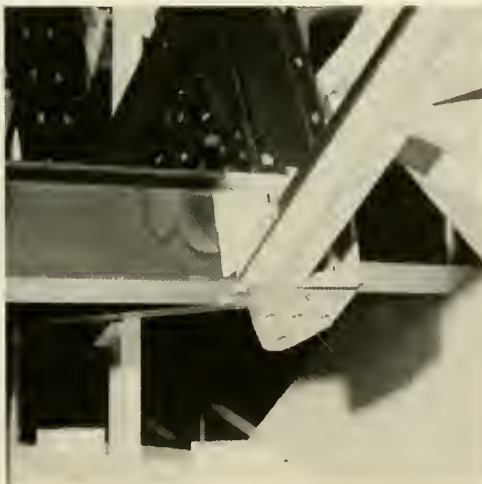
Figure 643 (Postflight). Longerons I between rows 8 and 9 with the Earth-facing end to the right is shown in this photograph. The side of tray A9 was adjacent to this longeron. There is a large pattern of discoloration on the longeron. There is a distinct line of concentrated discoloration at the thermal panel edge location. This discoloration was the effect of internal venting. The area covered by the tray flange contrasts with the unshielded area of the intercostal.

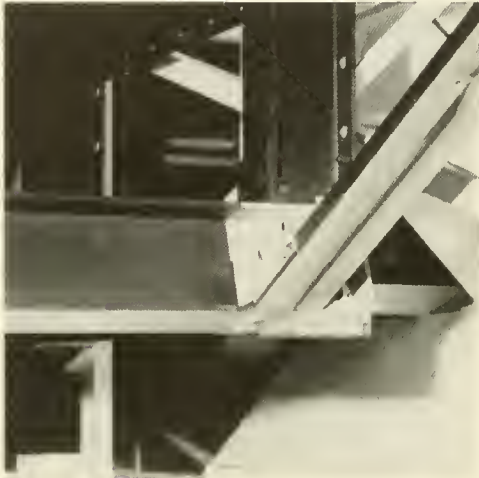
Figure 644 (Postflight). Longerons J between rows 9 and 10 with the Earth-facing end to the right is shown in this photograph. The side of tray A10 was adjacent to this longeron. There is little if any discoloration on the longeron. There is a distinct line of discoloration at the thermal panel edge location. The area covered by the tray flange contrasts with the unshielded area of the intercostal.

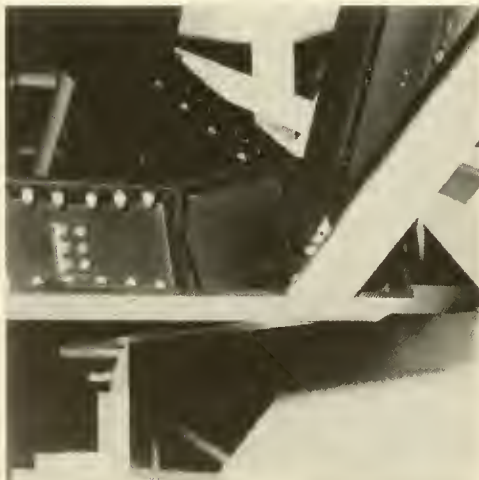
Figure 645 (Postflight). This photograph shows longeron K between rows 10 and 11 with the Earth-facing end to the right. The side of tray A11 was adjacent to this longeron. There is little if any discoloration on the longeron. There is a distinct line of discoloration at the thermal panel edge location. The area covered by the tray flange contrasts with the unshielded area of the intercostal.

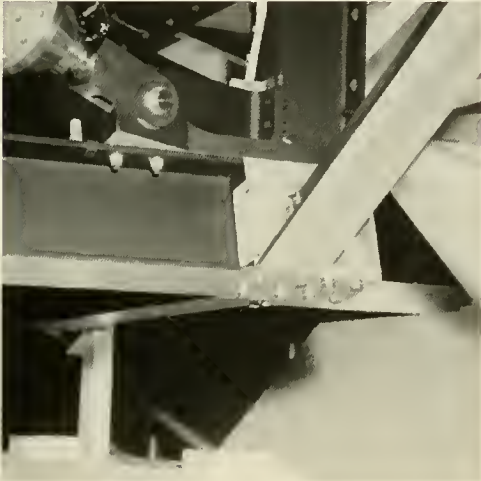
Figure 646 (Postflight). This photograph shows longeron L between rows 11 and 12 with the Earth-facing end to the right. The side of tray A12 was adjacent to this longeron. There is no discoloration on the longeron. There is no line of concentrated discoloration at the thermal panel edge location. The area covered by the tray flange contrasts with the unshielded area of the intercostal.

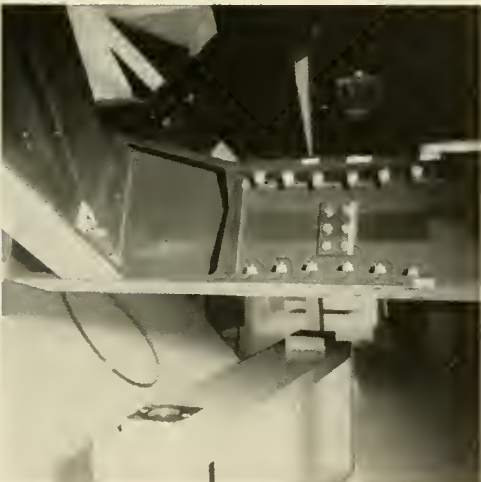
Figure 647 (Postflight). Tray A1 was adjacent to this part (left intercostal of bay A) of longeron B. Longeron B (Earth-facing end to left) was selected because of the distinct patterns on the longeron web. There is a significant and well-defined pattern of discoloration near the left intercostal.

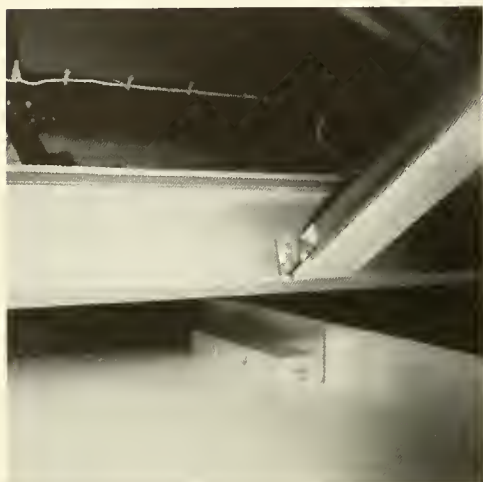
Figure 648 (Postflight). Tray A1 was adjacent to this part (right intercostal of bay A) of longeron B. The pattern fades near the center of the bay, but it gets darker near the right intercostal.

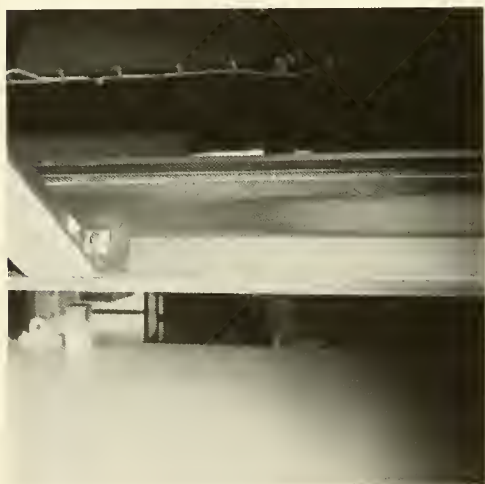
Figure 649 (Postflight). Tray B1 was adjacent to this part (left intercostal of bay B) of longeron B. There is a significant and well-defined pattern of discoloration with multiple shading near the left intercostal.

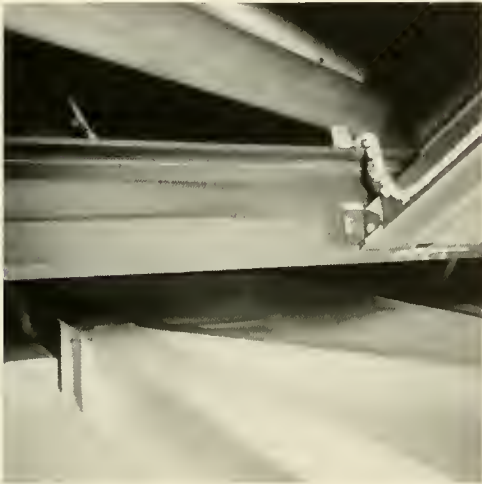
Figure 650 (Postflight). Tray B1 was adjacent to this part (right intercostal of bay B) of longeron B. There is a significant and well-defined pattern of discoloration with multiple shading near the right intercostal.

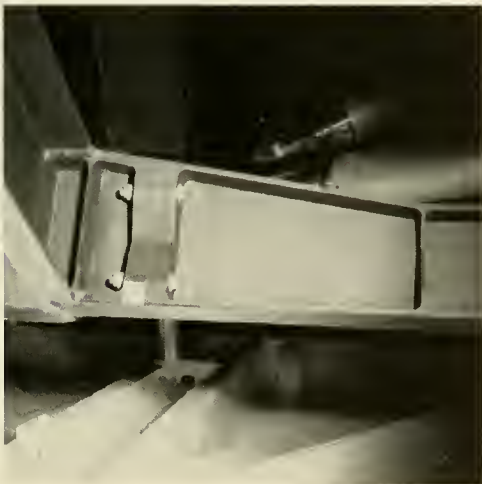
Figure 651 (Postflight). Tray D1 was adjacent to this part (center ring of bay D) of longeron B. There is a small faint pattern of discoloration on the longeron near the center ring.

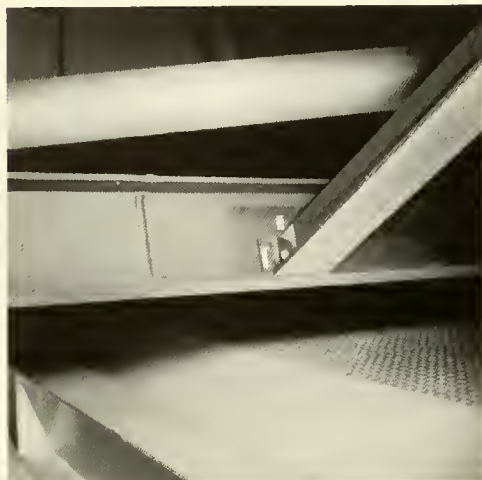
Figure 652 (Postflight). Tray D1 was adjacent to this part (right intercostal of bay D) of longeron B. There is a distinct pattern of discoloration near the right intercostal but none in the center.

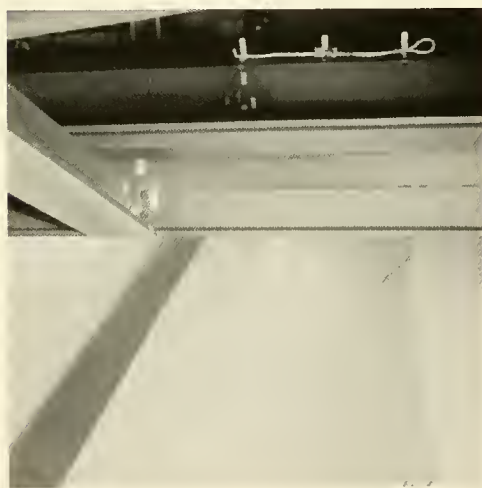
Figure 653 (Postflight). Tray E1 was adjacent to this part (left intercostal of bay E) of longeron B. There is a significant and well defined pattern of discoloration with multiple shadings near the left intercostal.

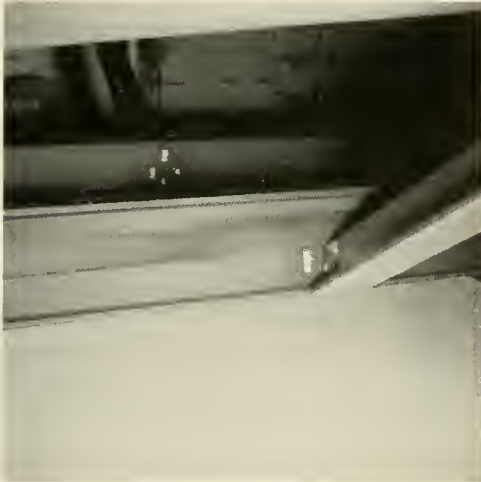
Figure 654 (Postflight). Tray E1 was adjacent to this part (right intercostal of bay E) of longeron B. There is a significant and well defined pattern of discoloration with multiple shadings near the right intercostal.

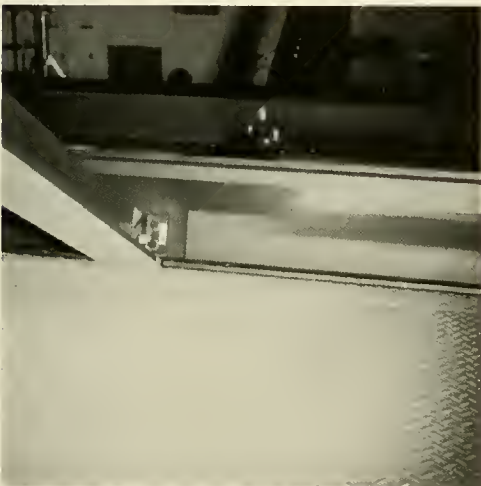
Figure 655 (Postflight). Tray F1 was adjacent to this part (left intercostal of bay F) of longeron B. There is a significant and well defined pattern of discoloration with multiple shadings near the left intercostal.

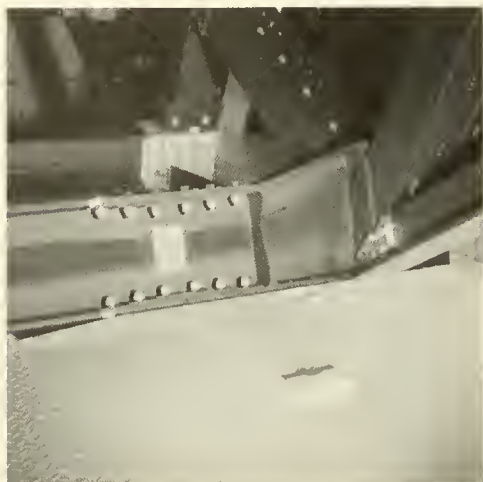
Figure 656 (Postflight). Tray F1 was adjacent to this (right intercostal of bay F) part of longeron B. There is a significant and well defined pattern of discoloration with multiple shadings near the right intercostal.

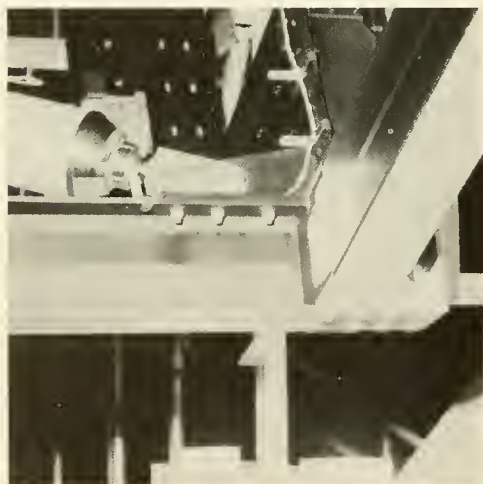
Figure 657 (Postflight). Tray A6 was adjacent to this part (right intercostal of bay A) of longeron F. The Earth-facing end of LDEF is to the right in this photograph, which shows longeron F between rows 5 and 6. There is a significant and well-defined pattern of discoloration near the right intercostal. Note the sharp patterns of the bolts and wiring clamp.

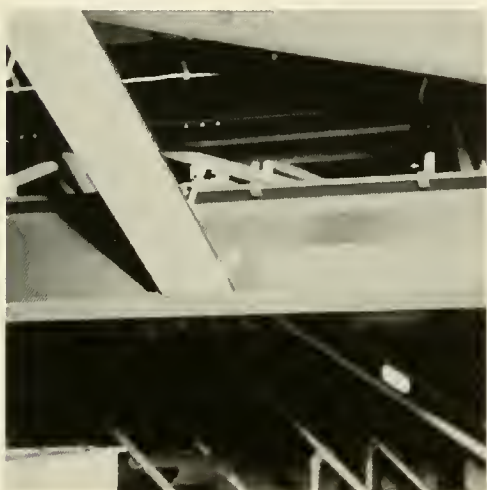
Figure 658 (Postflight). Tray A6 was adjacent to this part (left intercostal of bay A) of longeron F. There is a significant and well defined pattern of discoloration near the left intercostal. Note the wiring clamp patterns.

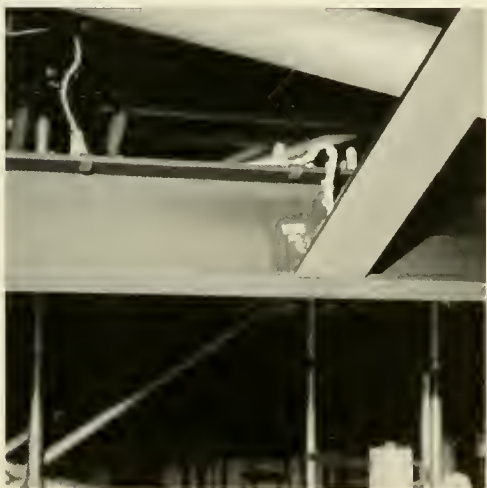
Figure 659 (Postflight). Tray B6 was adjacent to this part (right intercostal of bay B) of longeron F. There is a significant and well-defined pattern of discoloration near the right intercostal. Note the wiring clamp and wiring wrap patterns. The patterns fade near the center of the bay.

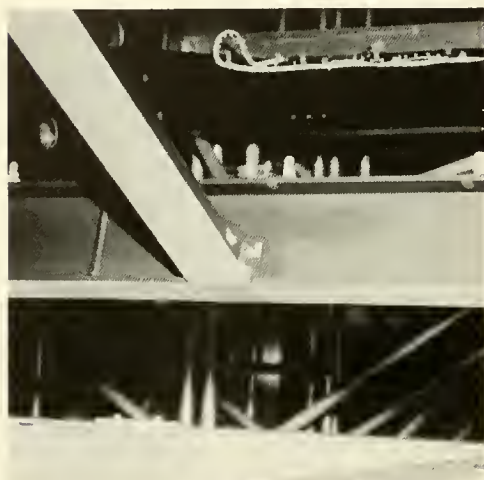
Figure 660 (Postflight). Tray B6 was adjacent to this part (left intercostal of bay B) of longeron F. There is a significant and well-defined pattern of discoloration near the left intercostal. Note the faint pattern of the wiring clamp. The pattern fades near the center of the bay.

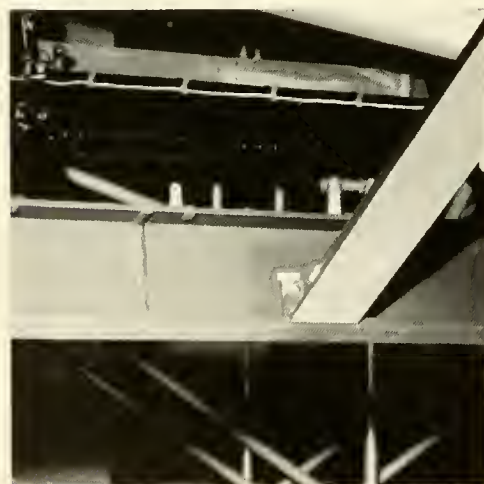
Figure 661 (Postflight). Tray C6 was adjacent to this part (right intercostal of bay C) of longeron F. There is a significant and well-defined pattern of discoloration with distinctly different shadings near the right intercostal. Note the sharp cutoff of the discoloration just to the left of the intercostal.

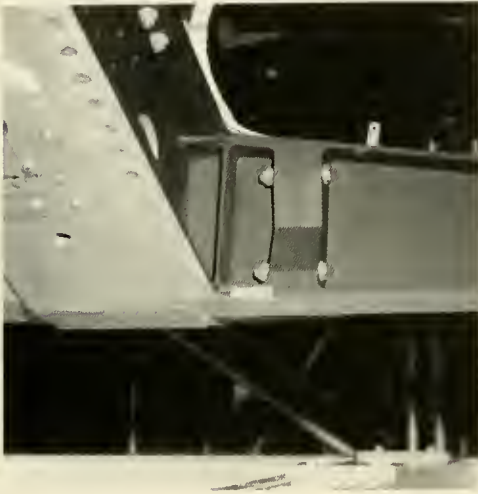
Figure 662 (Postflight). Tray C6 was adjacent to this part (center ring of bay C) of long-eron F. There is a faint indication of a pattern of discoloration near the center ring.

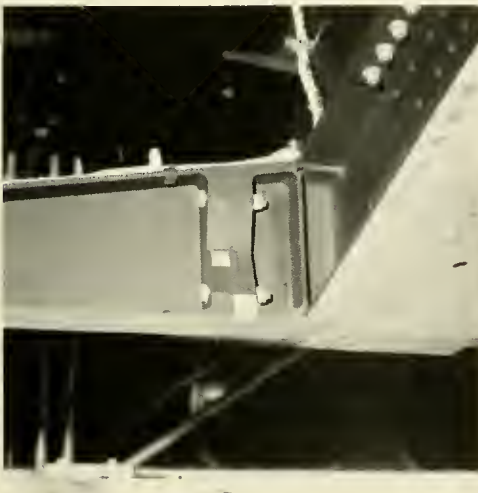
Figure 663 (Postflight). Tray D6 was adjacent to this (center ring of bay D) part of long-eron F. There is a small pattern of discoloration near the center ring.

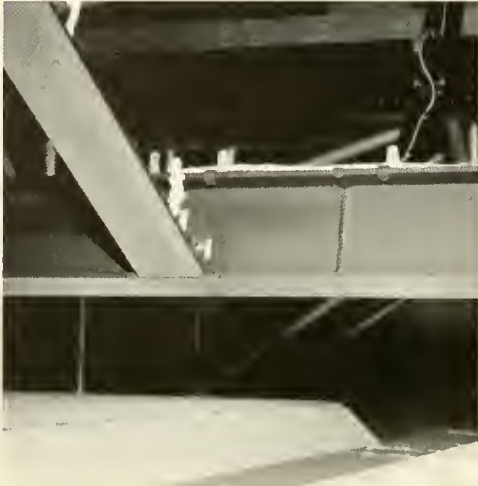
Figure 664 (Postflight). Tray D6 was adjacent to this part (left intercostal of bay D) of longeron F. There is a significant and well-defined pattern of discoloration near the left intercostal. Note the faint wire clamp pattern. The pattern fades near the center of the bay.

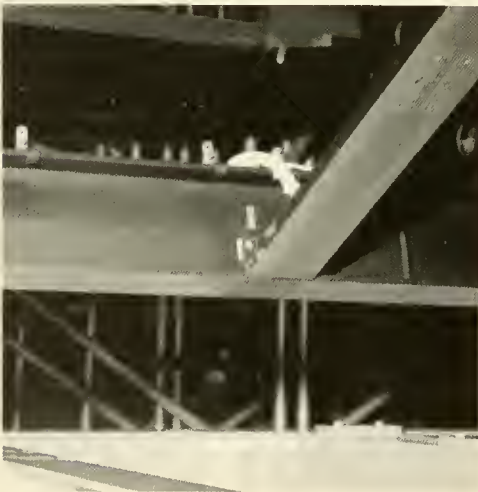
Figure 665 (Postflight). Tray E6 was adjacent to this part (right intercostal of bay E) of longeron F. There is a distinct and well-defined pattern of discoloration. Note the wire clamp patterns.

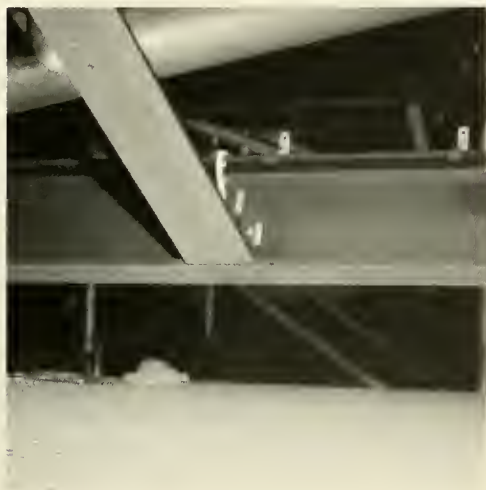
Figure 666 (Postflight). Tray E6 was adjacent to this part (left intercostal of bay E) of longeron F. There is a significant and well-defined pattern of discoloration.

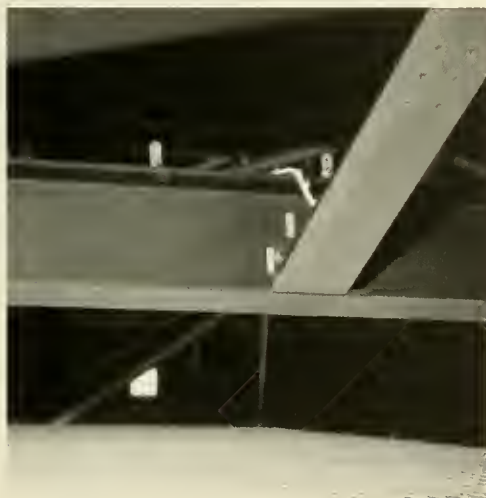
Figure 667 (Postflight). Tray F6 was adjacent to this part (right intercostal of bay F) of longeron F. There is a faint pattern of discoloration near the right intercostal. There is also a sharp cutoff of the discoloration just to the left of the intercostal.

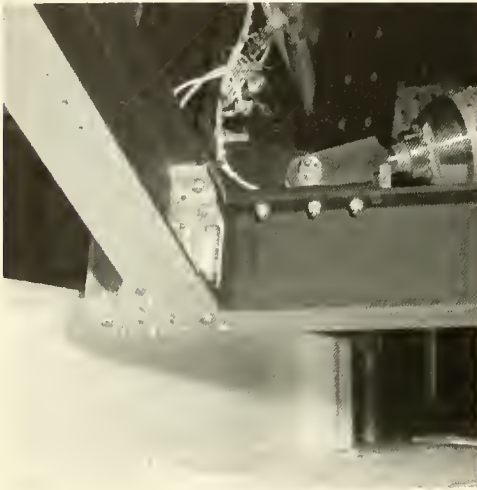
Figure 668 (Postflight). Tray F6 was adjacent to this part (left intercostal of bay F) of long-eron F. There is a small but distinct pattern of discoloration near the left intercostal.

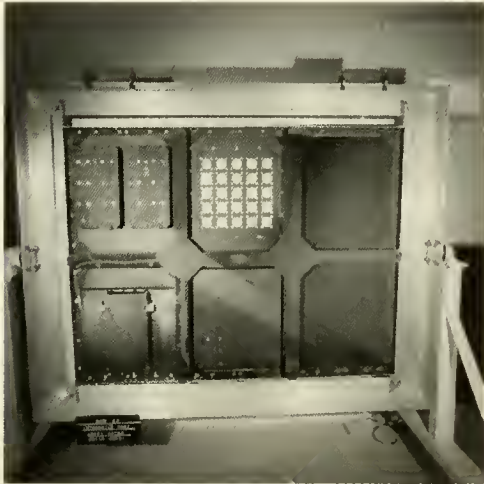
Figure 669 (Postflight). Note the extensive contamination and discoloration. There is the pattern of a diagonal structural member across the back of the tray. There is also a pattern where a wiring harness has been removed from the lower left tray members.

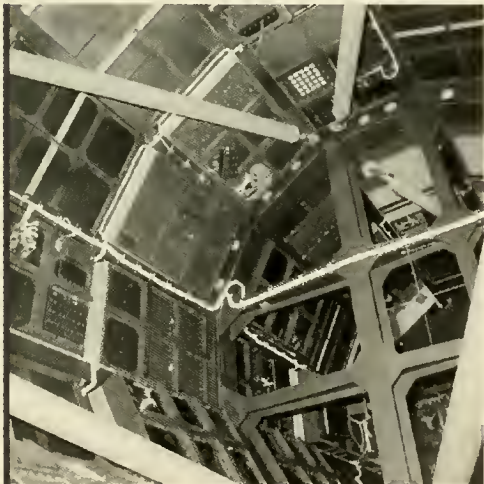
Figure 670 (Postflight). The interior of the LDEF was essentially black to provide radiative coupling in thermal control of the facility. Note the pattern of discoloration on the back of tray B2 in the top left of the photograph.

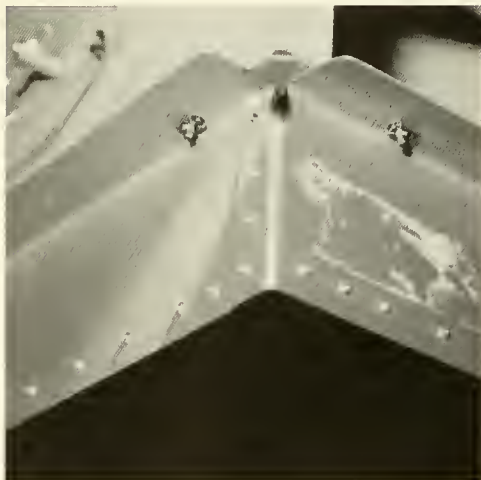
Figure 671 (Postflight). This photograph of tray F11 shows extensive discoloration and contamination. Note the discoloration below the rivet heads. It appears that during tray manufacture or integration, tape had been placed on the tray sidewall and the tray was improperly cleaned after the tape was removed.

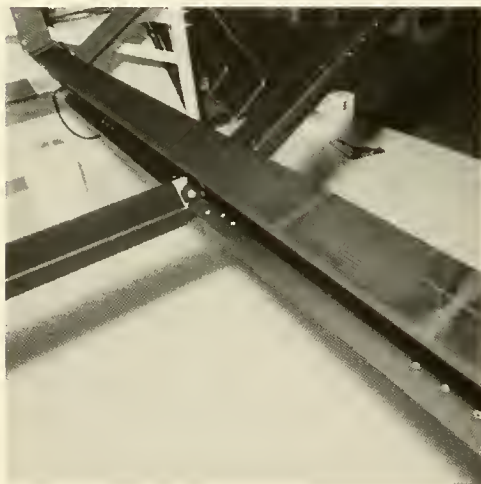
Figure 672 (Postflight). This photograph of the interior flange of the longeron D shows the discoloration pattern after the wiring harness and wire holding clips were removed.

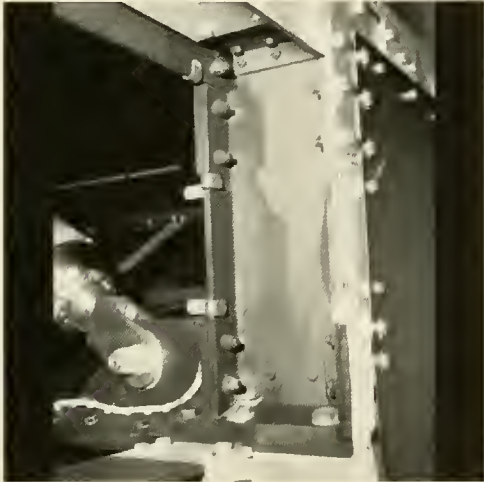
Figure 673 (Postflight). This photograph is of the structural member adjacent to the end of longeron F (between rows 5 and 6) at the Earth-facing end of the LDEF. Note the extensive color and highly directional patterns of the bolts and nuts.

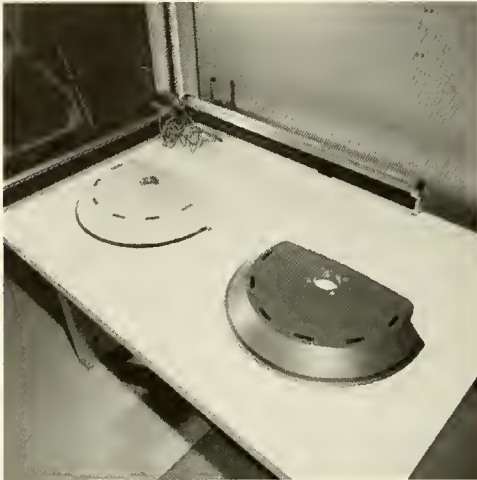
Figure 675 (Postflight). This set of trunnion scuff plates was removed from the LDEF after flight. The brighter scuff plate was on the leading side during flight, while the duller one was on the trailing side.
